The Martian Landscape

By The Viking Lander Imaging Team

Scientific and Technical Information Office
NATIONAL AERONAUTICS AND SPACE ADMINISTRATION
Washington, D.C. 1978

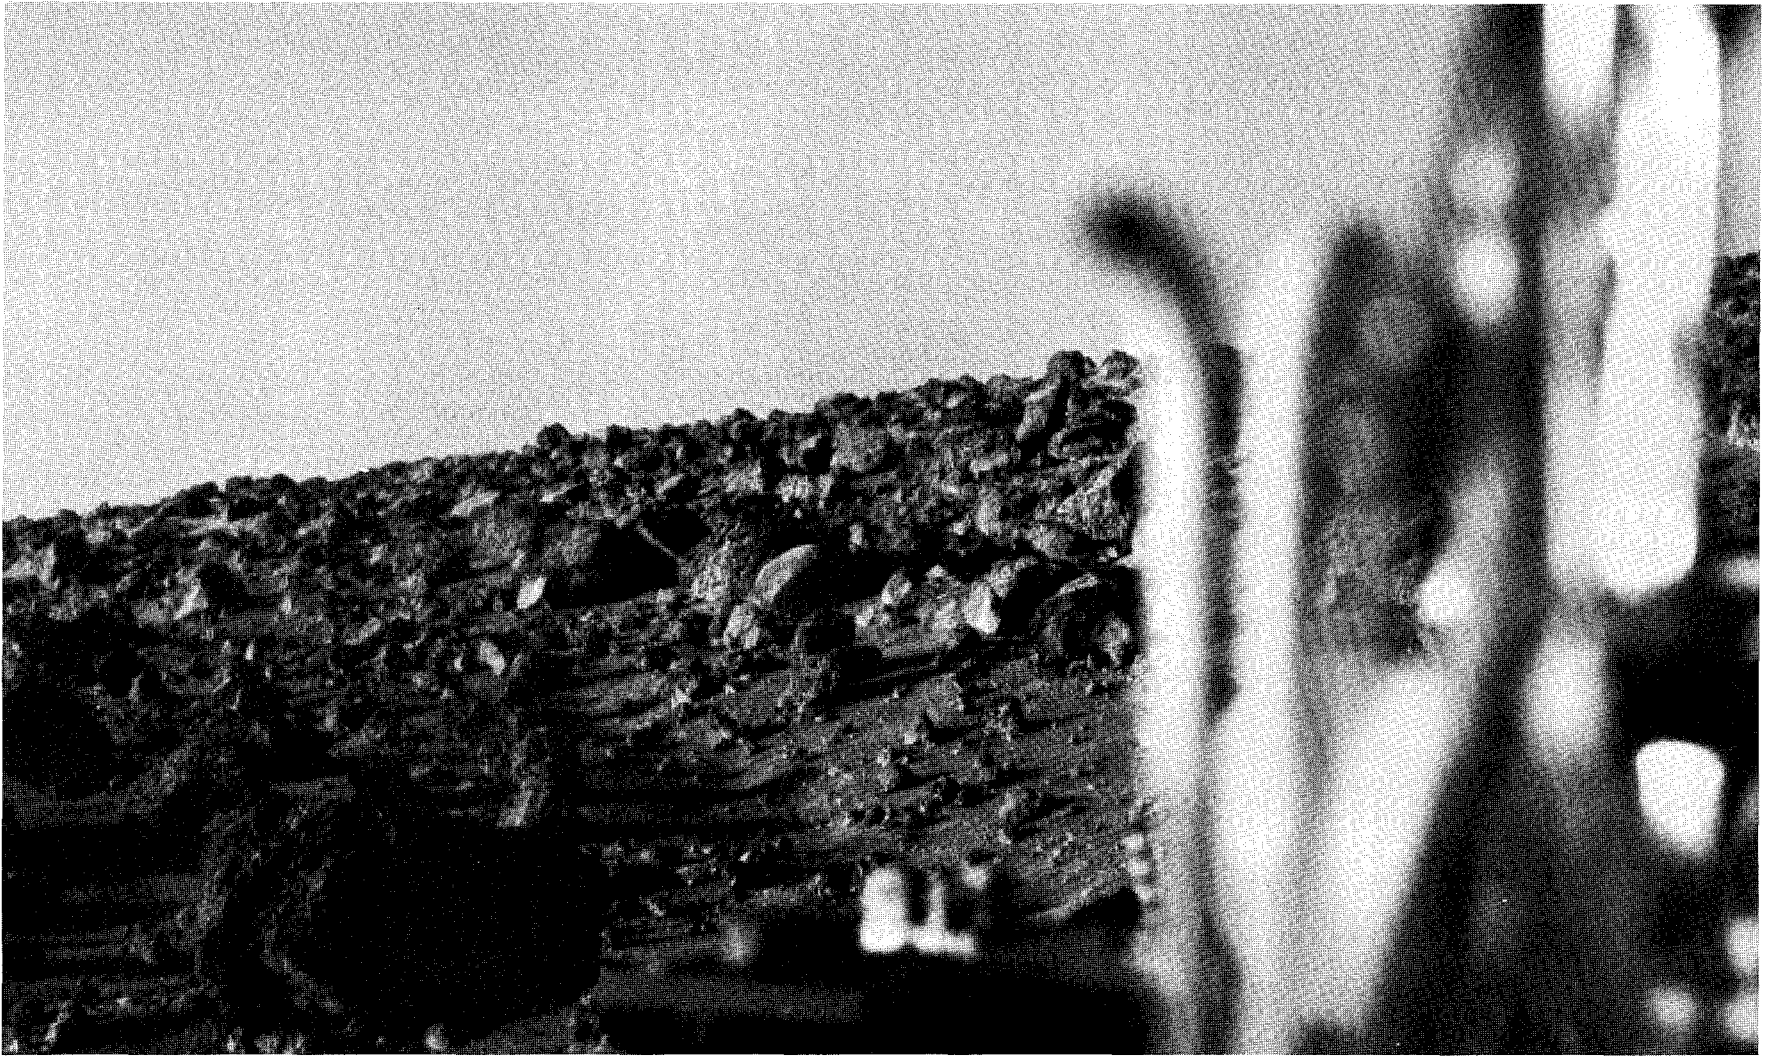
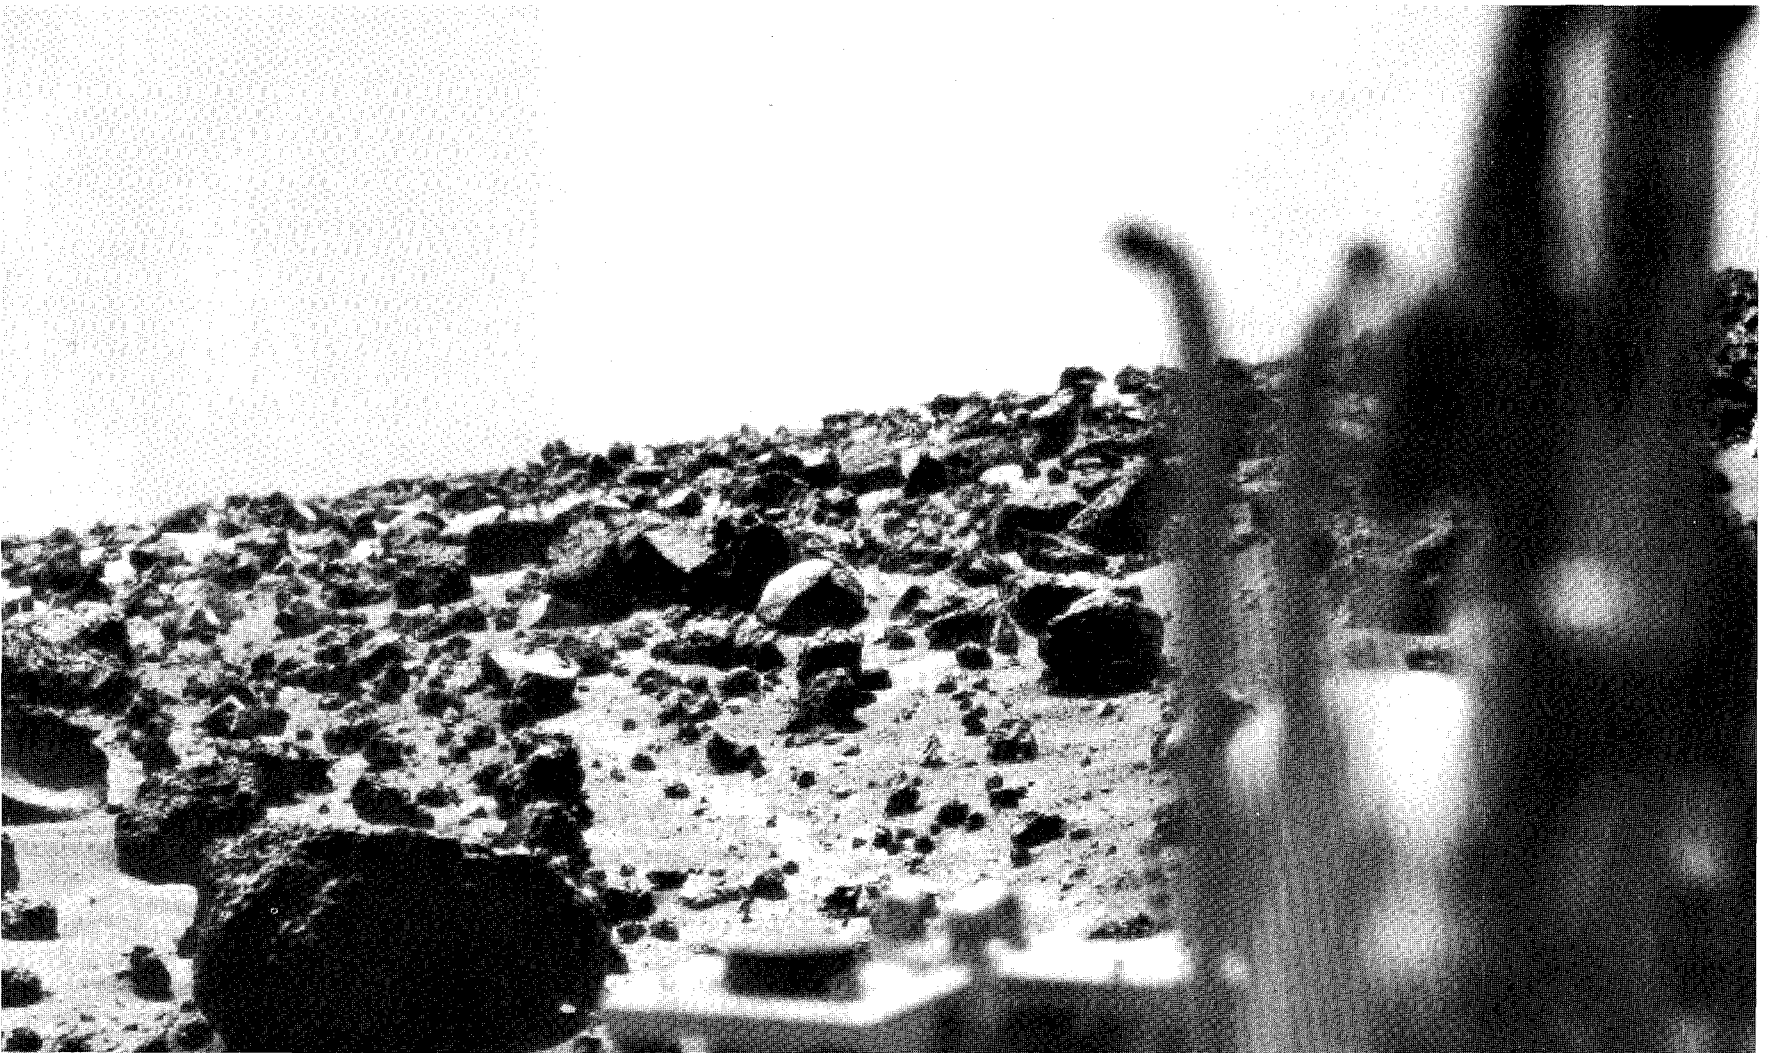
As was the case for Lander 1, some of the more fascinating Lander 2 pictures are those taken looking back across the spacecraft. Figures 107 and 108 show an early morning and midday view of the same region. The pipes at the right were connected to the Orbiter during the trip to Mars in order to stabilize and monitor the internal Lander environment. The top of leg 1, at the rear of the triangular spacecraft, occurs in the bottom center.

Although most of the blocks on the surface are irregularly broken and pitted, some have smooth, conchoidal fractures.

An example appears at the far left in figure 108. This morphology is typical for glassy to fine-grained volcanic rocks.

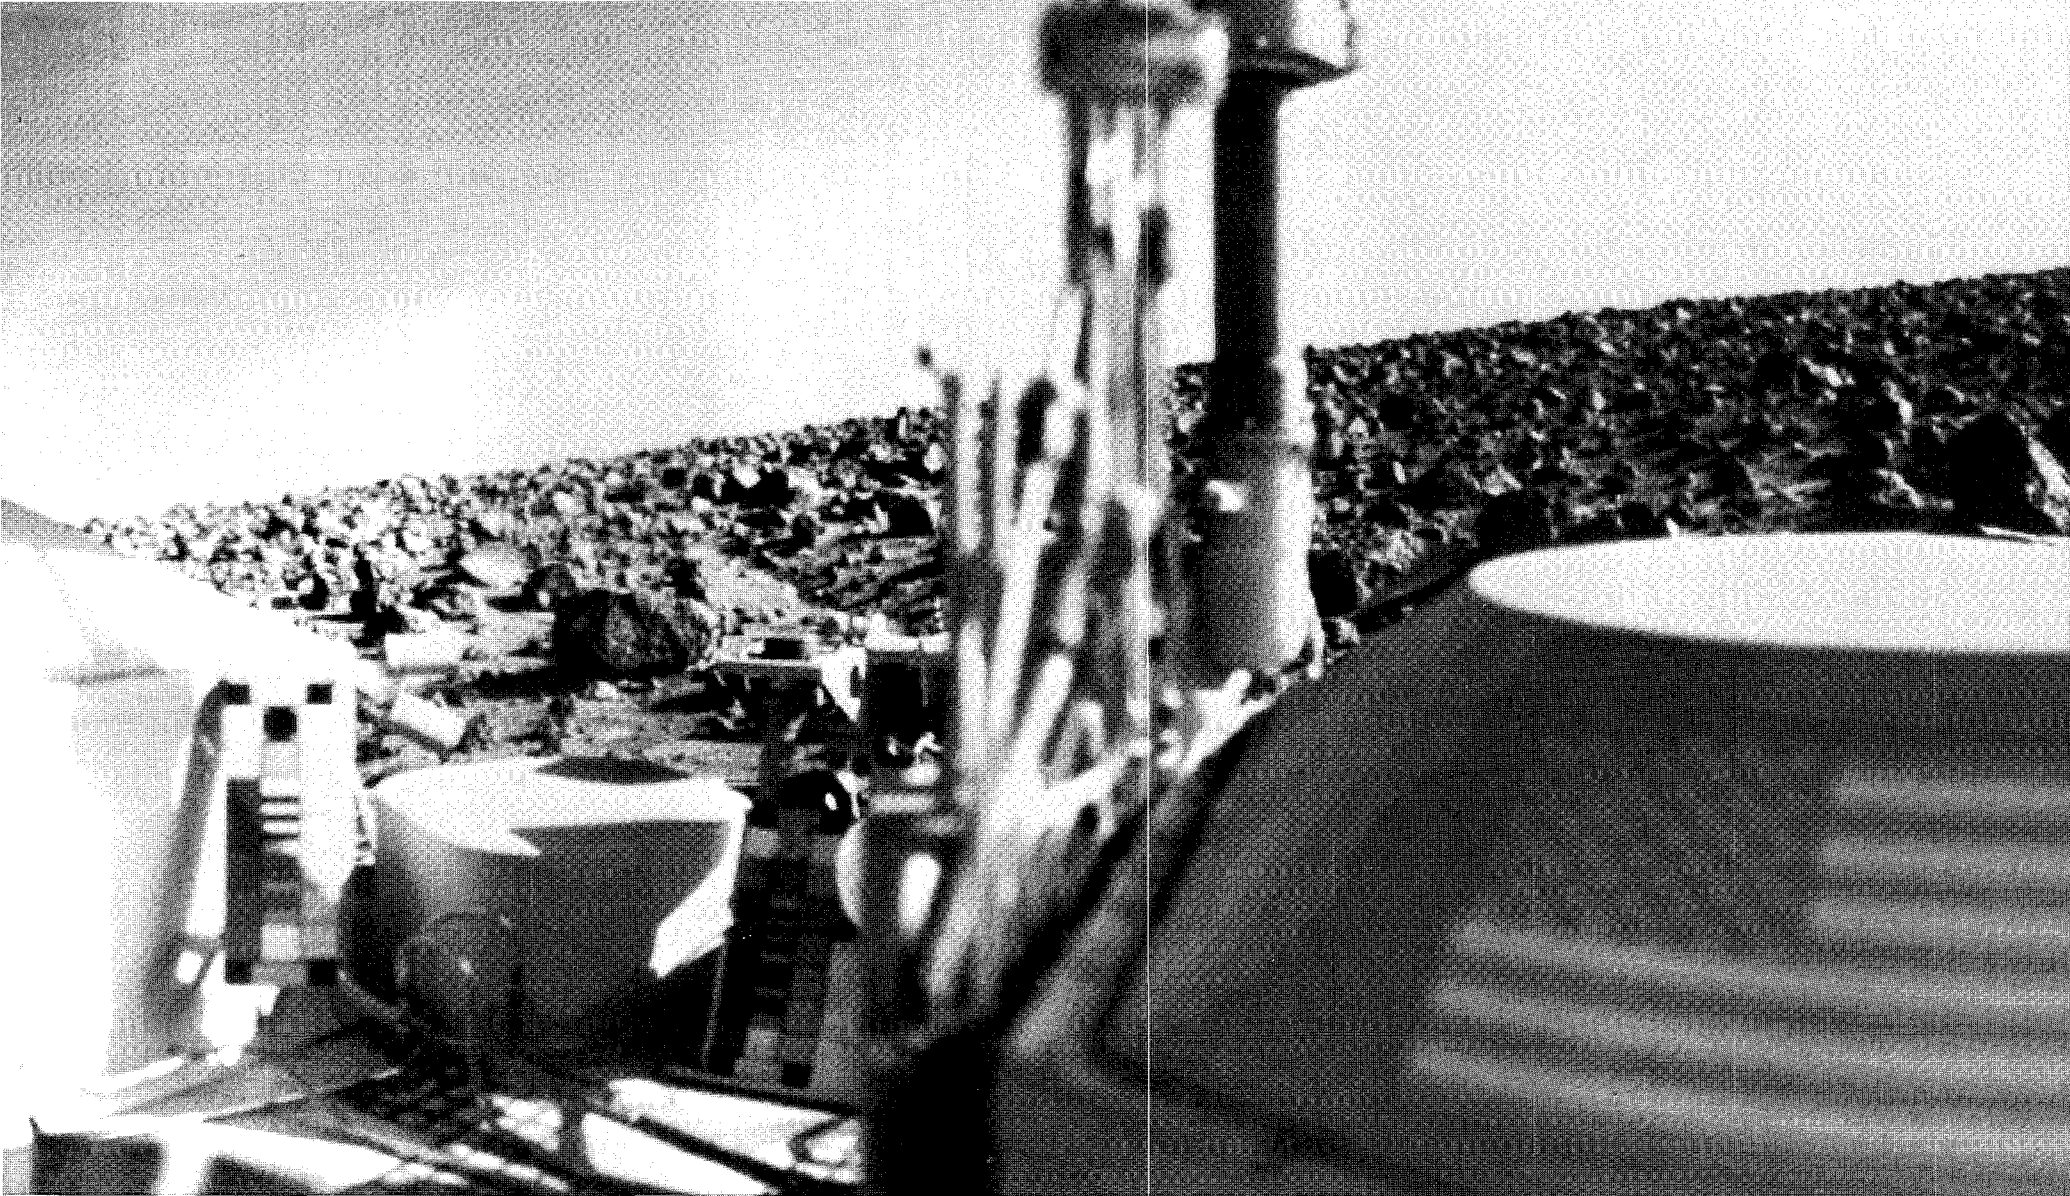
FIGURE 109

Figure 109 is a low-resolution view showing a larger area than that contained in the high-resolution views of figures 107 and 108. A large number of spacecraft components are identifiable, including the RTG protective covers, two of three reference test targets for the cameras, and the dish-shaped S-band antenna.

Brightness contouring in the sky, particularly well developed in figure 109 but detectable in many other pictures, is

caused by increasing sky brightness as the camera moves toward the Sun. The Lander camera transforms this continuous gradation into a series of discrete steps with increasing brightness. The filamentous horizontal bright streaks in the sky are caused by spurious reflections of light from the outer camera housing. When the camera mirror is at certain critical positions, this light interferes with the normal radiance of the scene.

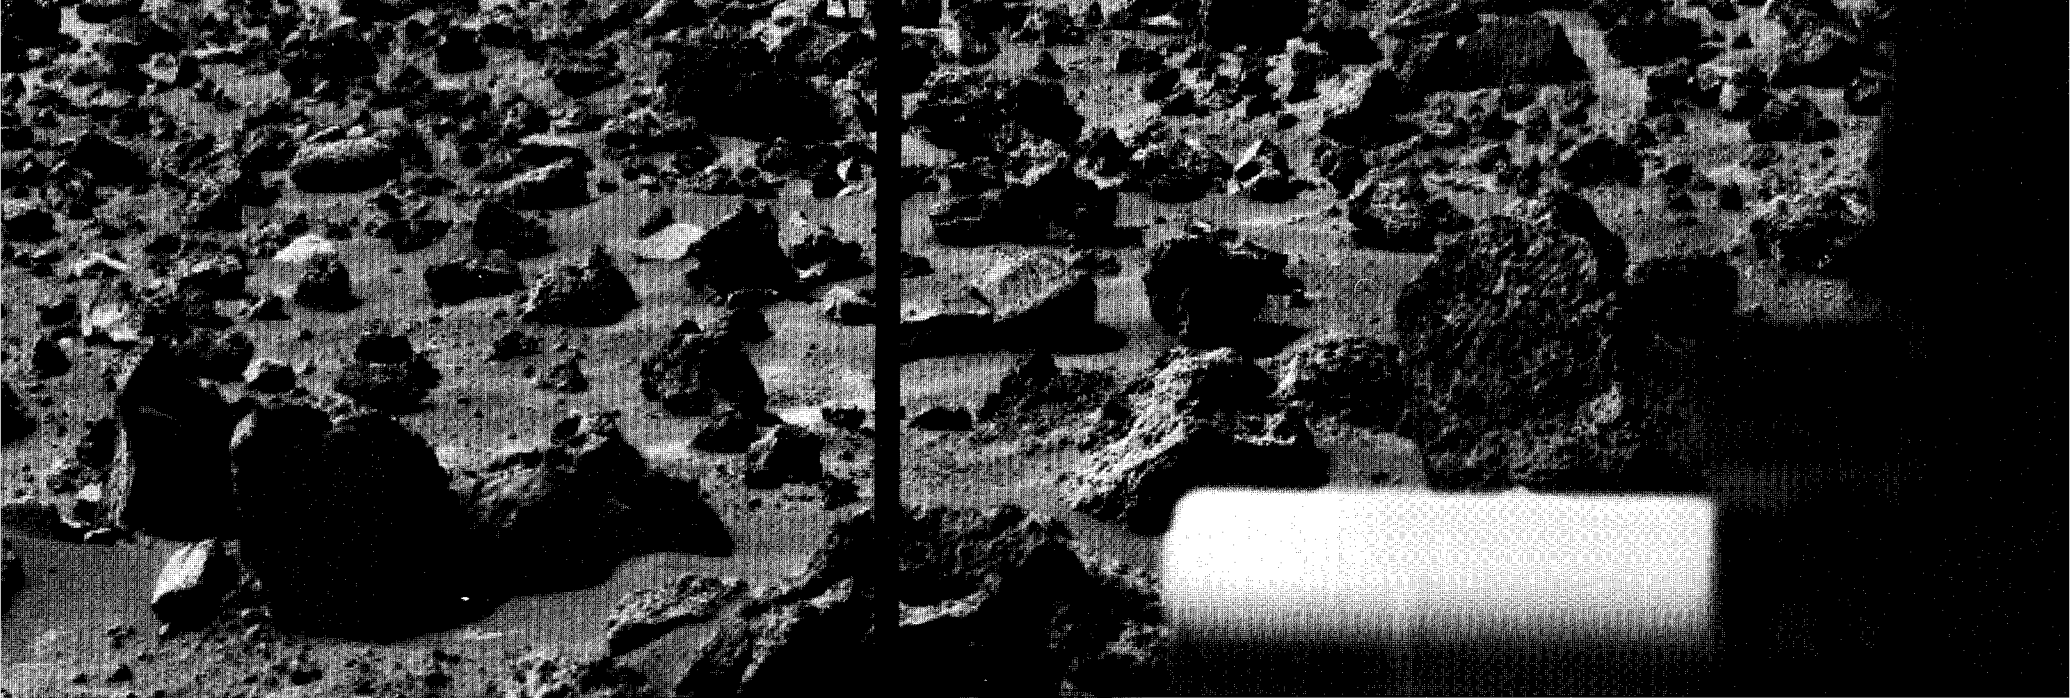
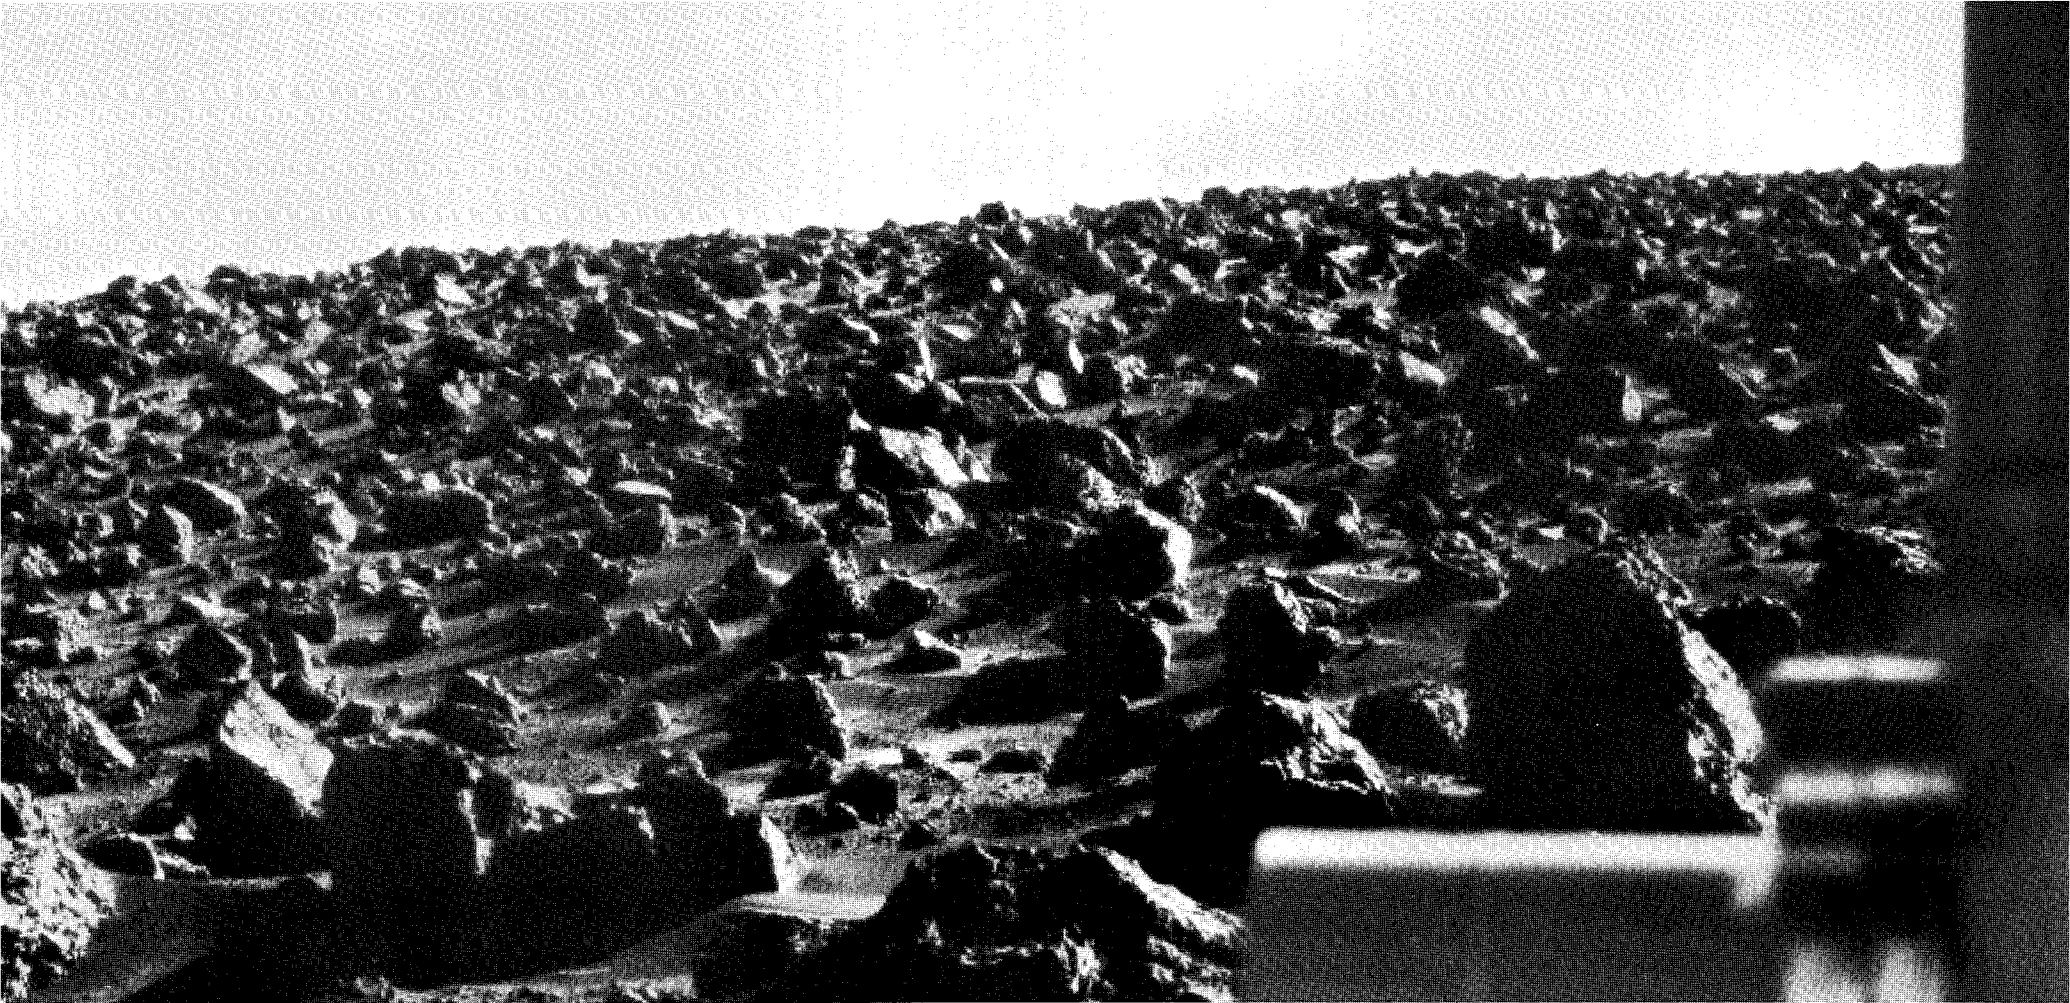
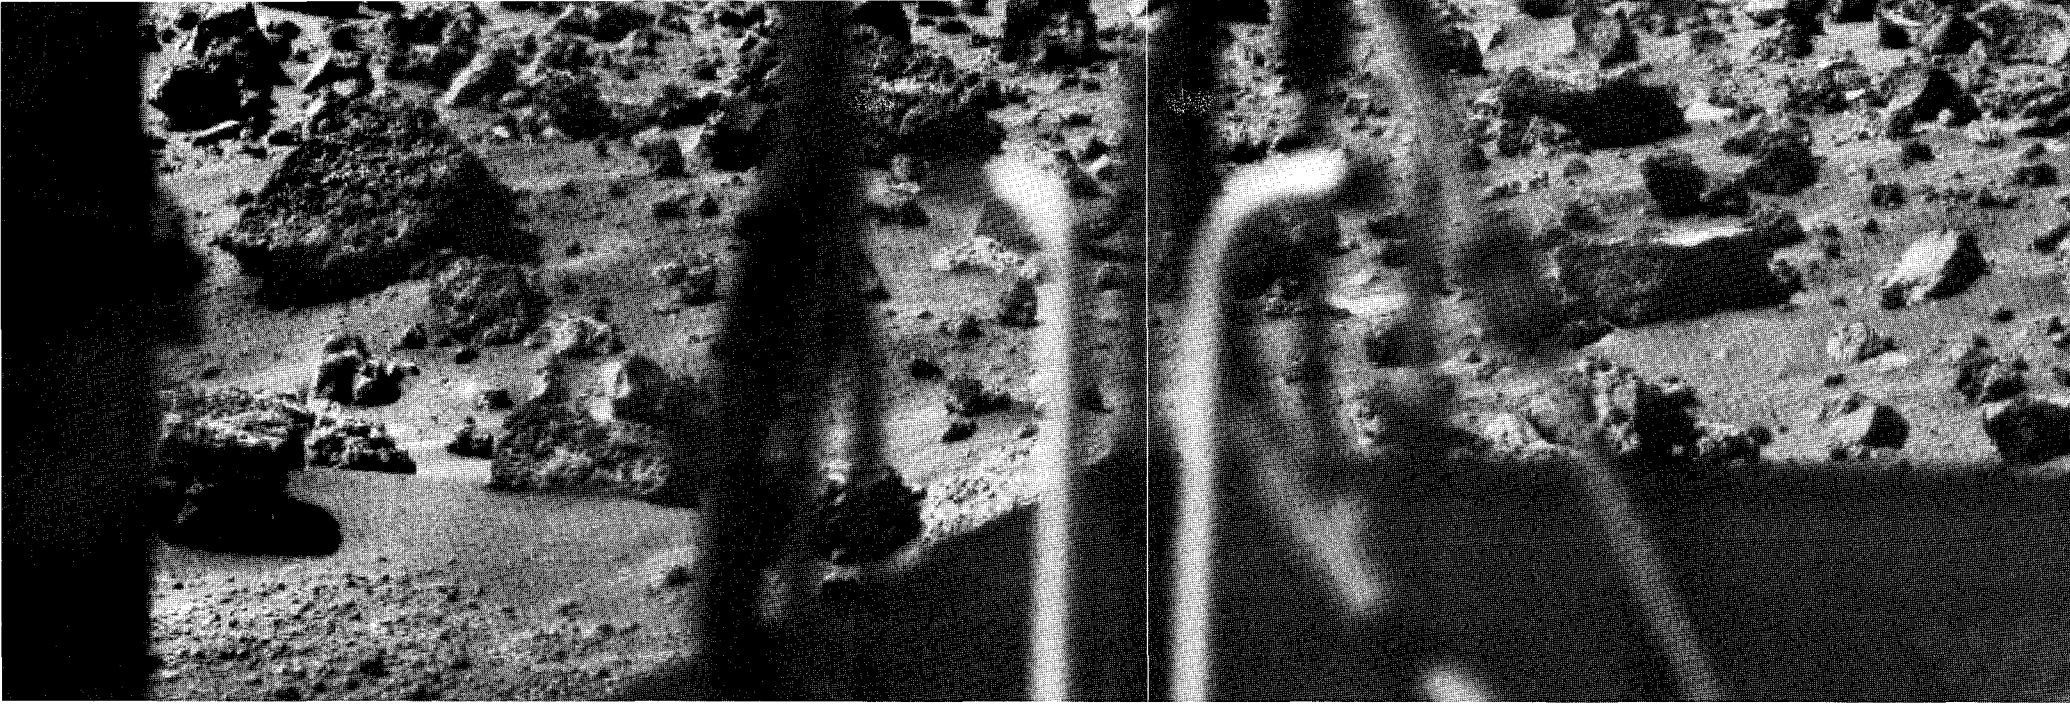
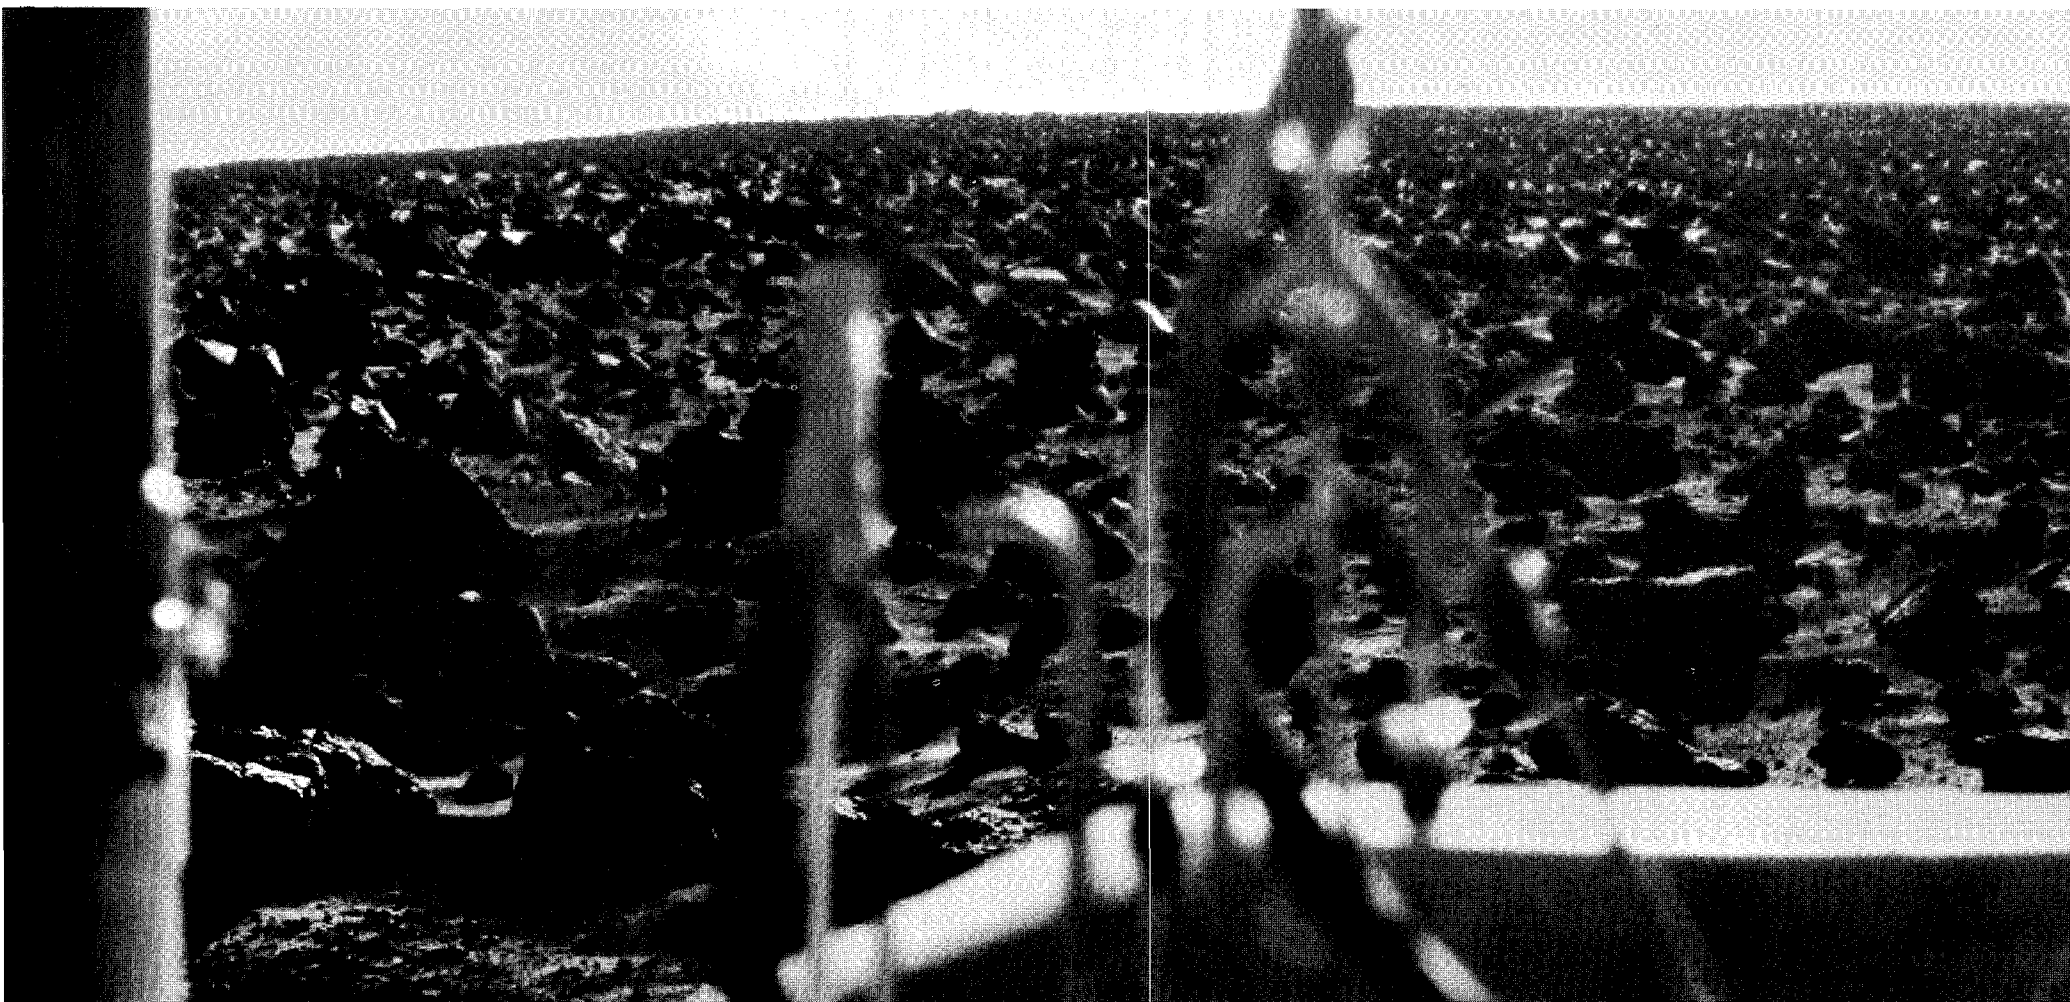
Figures 110 and 111 are panoramas looking toward the southwest at different times of day. The hinge assembly on the S-band antenna is prominently

shown left of center in both figures. The vertical upper mast appears at the center. The horizon near the left edge of the scene is much closer than at the right,

because of the presence of a small rise. One result is that individual blocks are visible on the horizon to the left but not to the right.

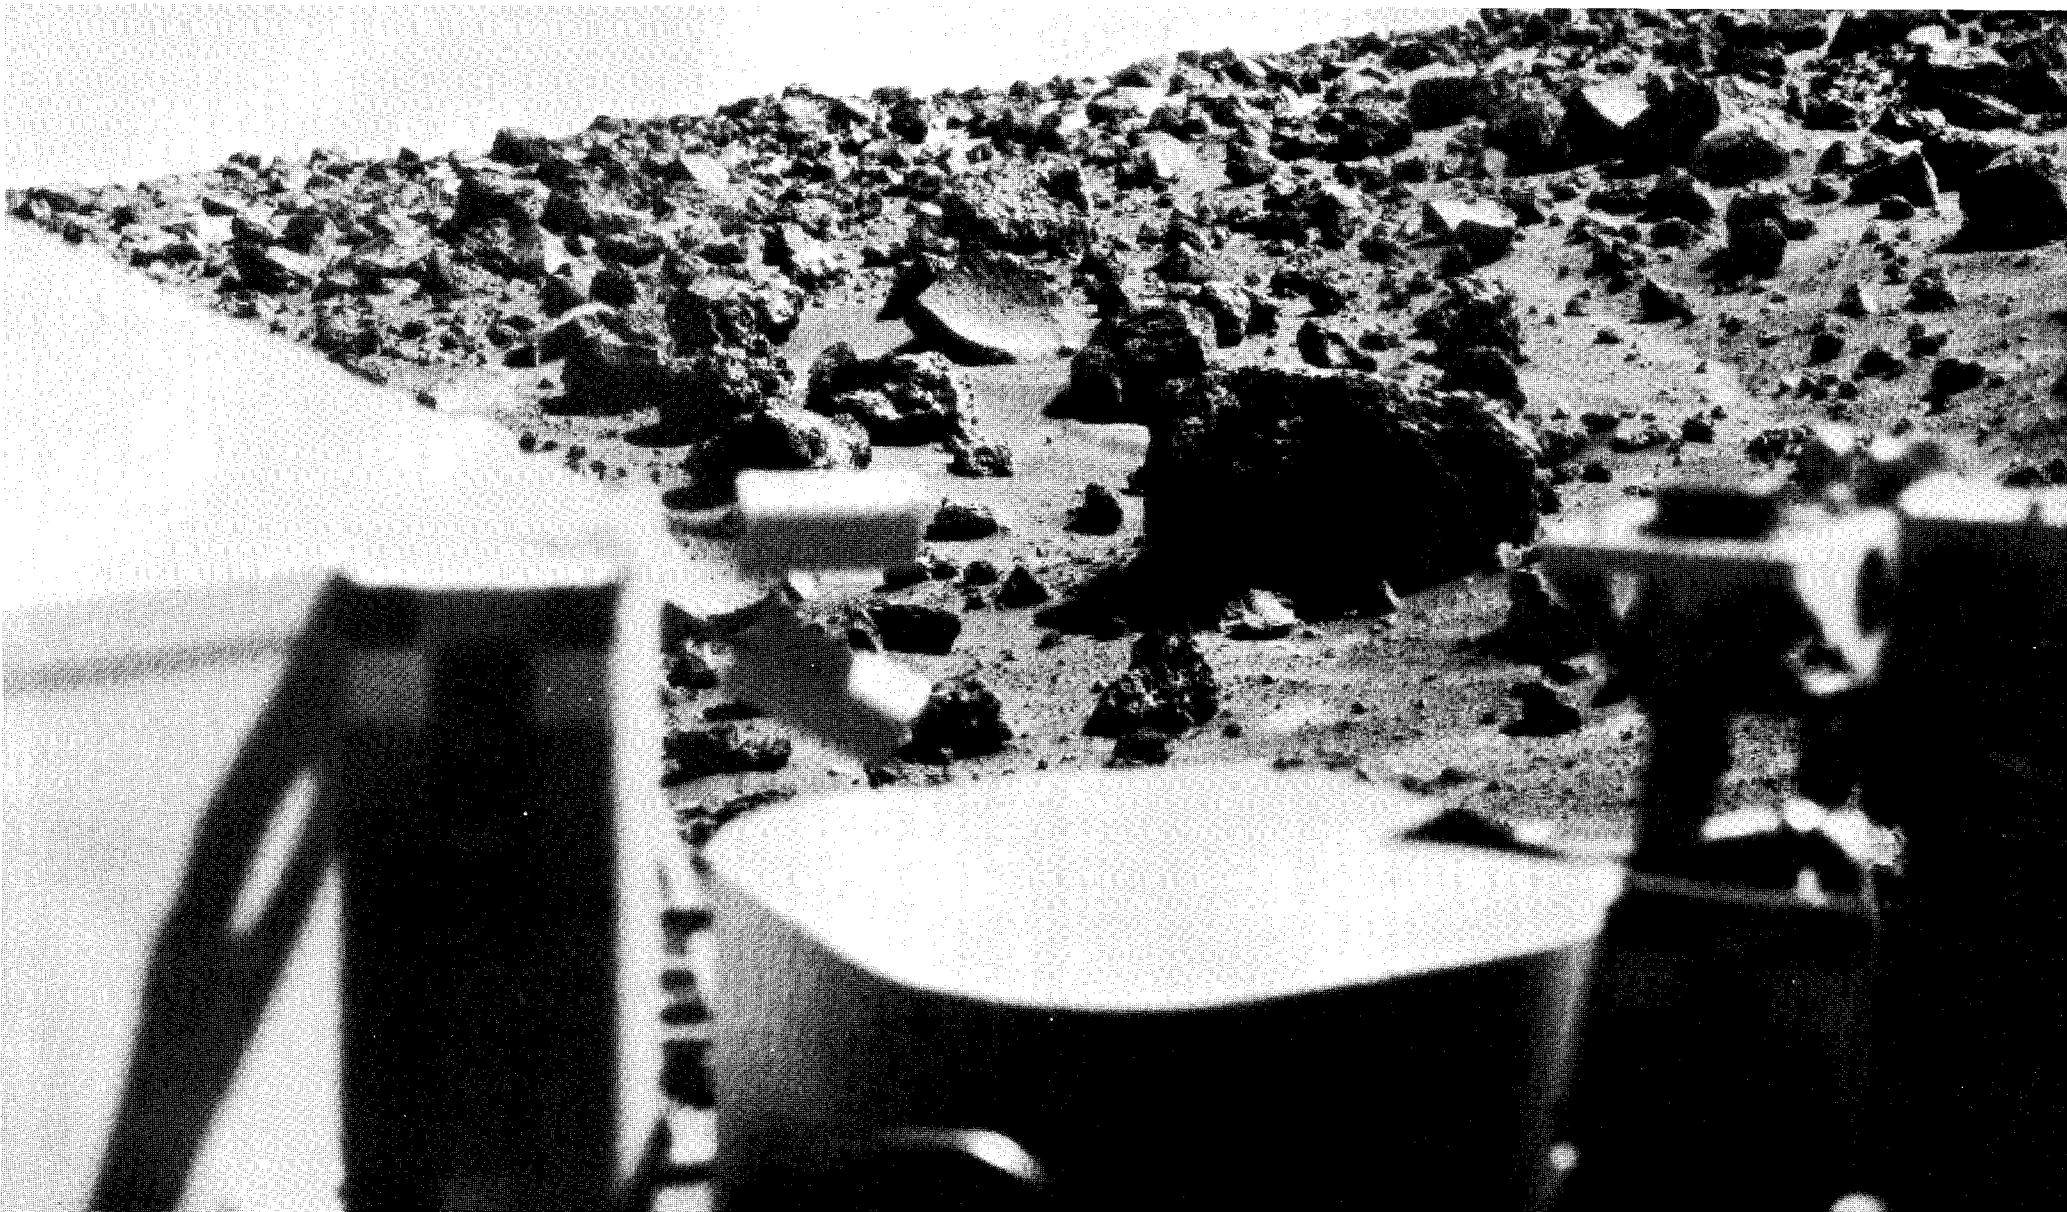
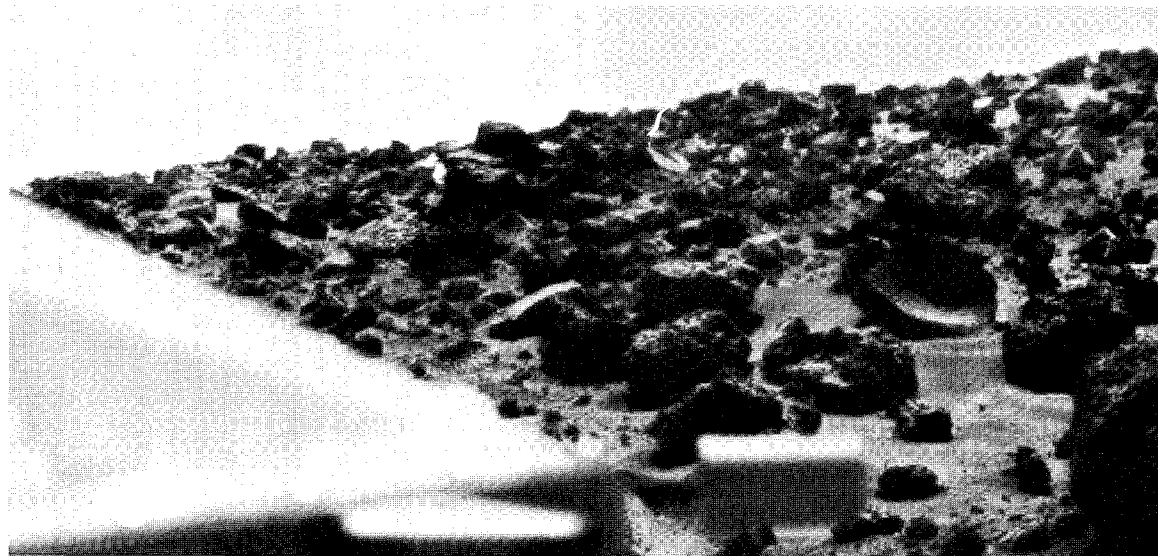
Two pairs of views behind the spacecraft are shown. Figures 112 and 113 show a distinctive conchoidally fractured block near the middle of the scene.

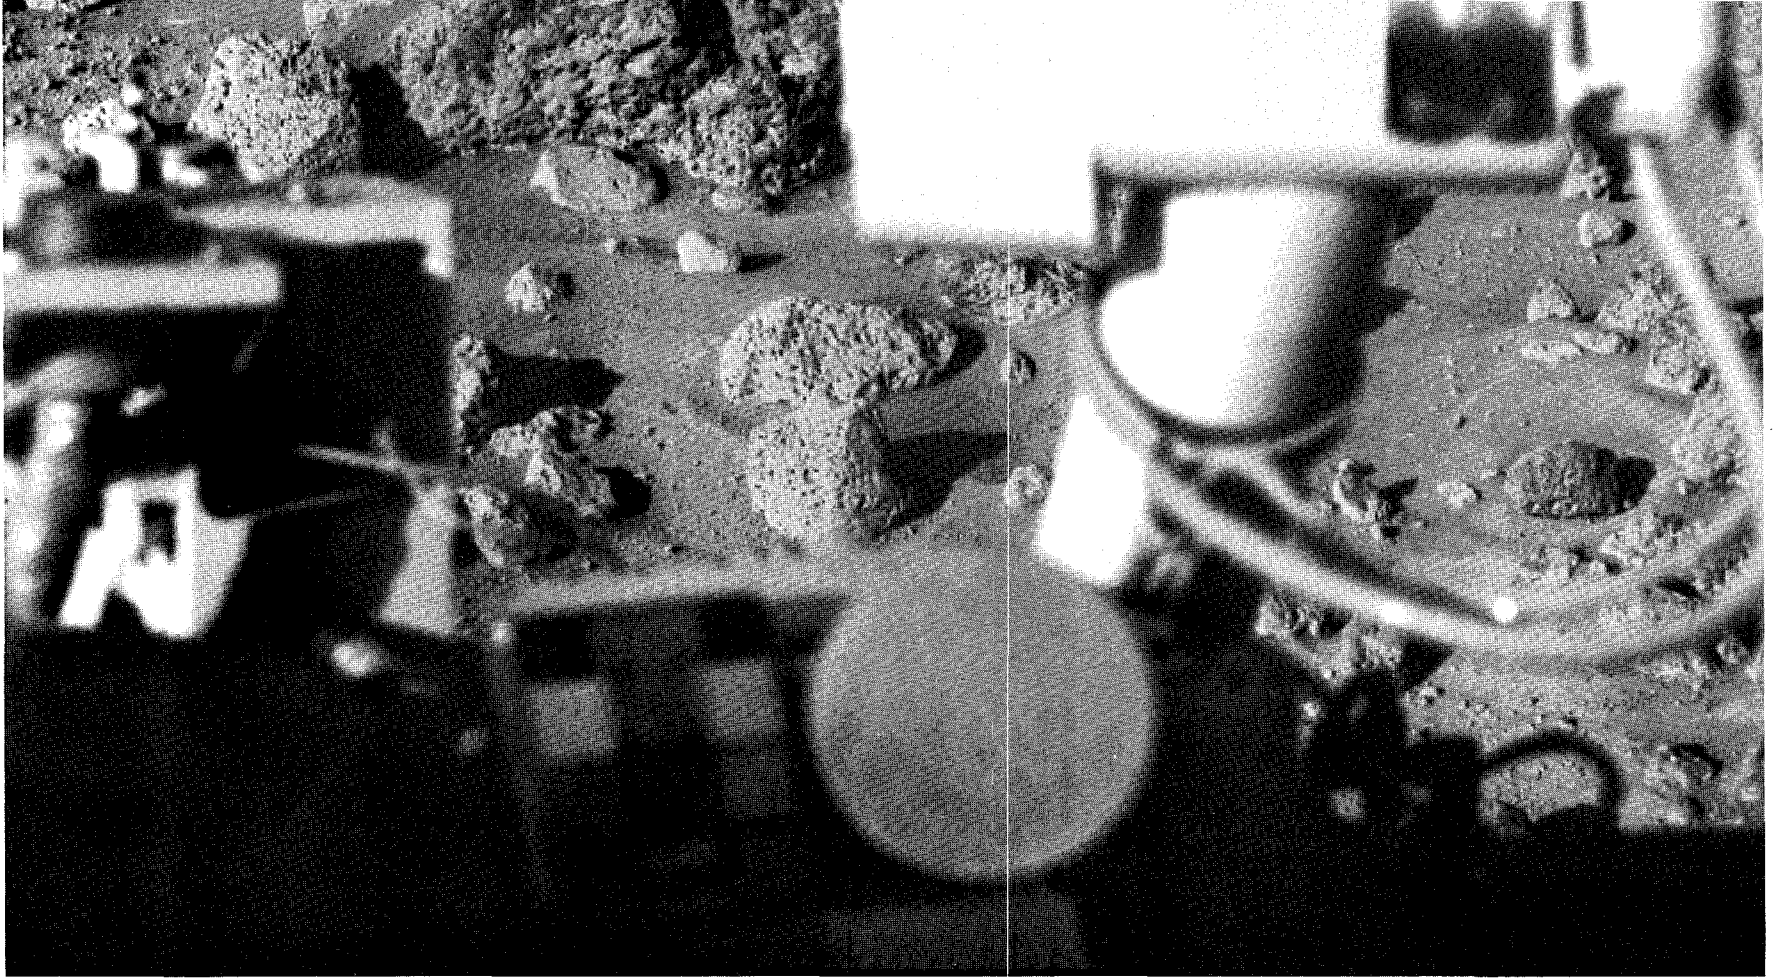
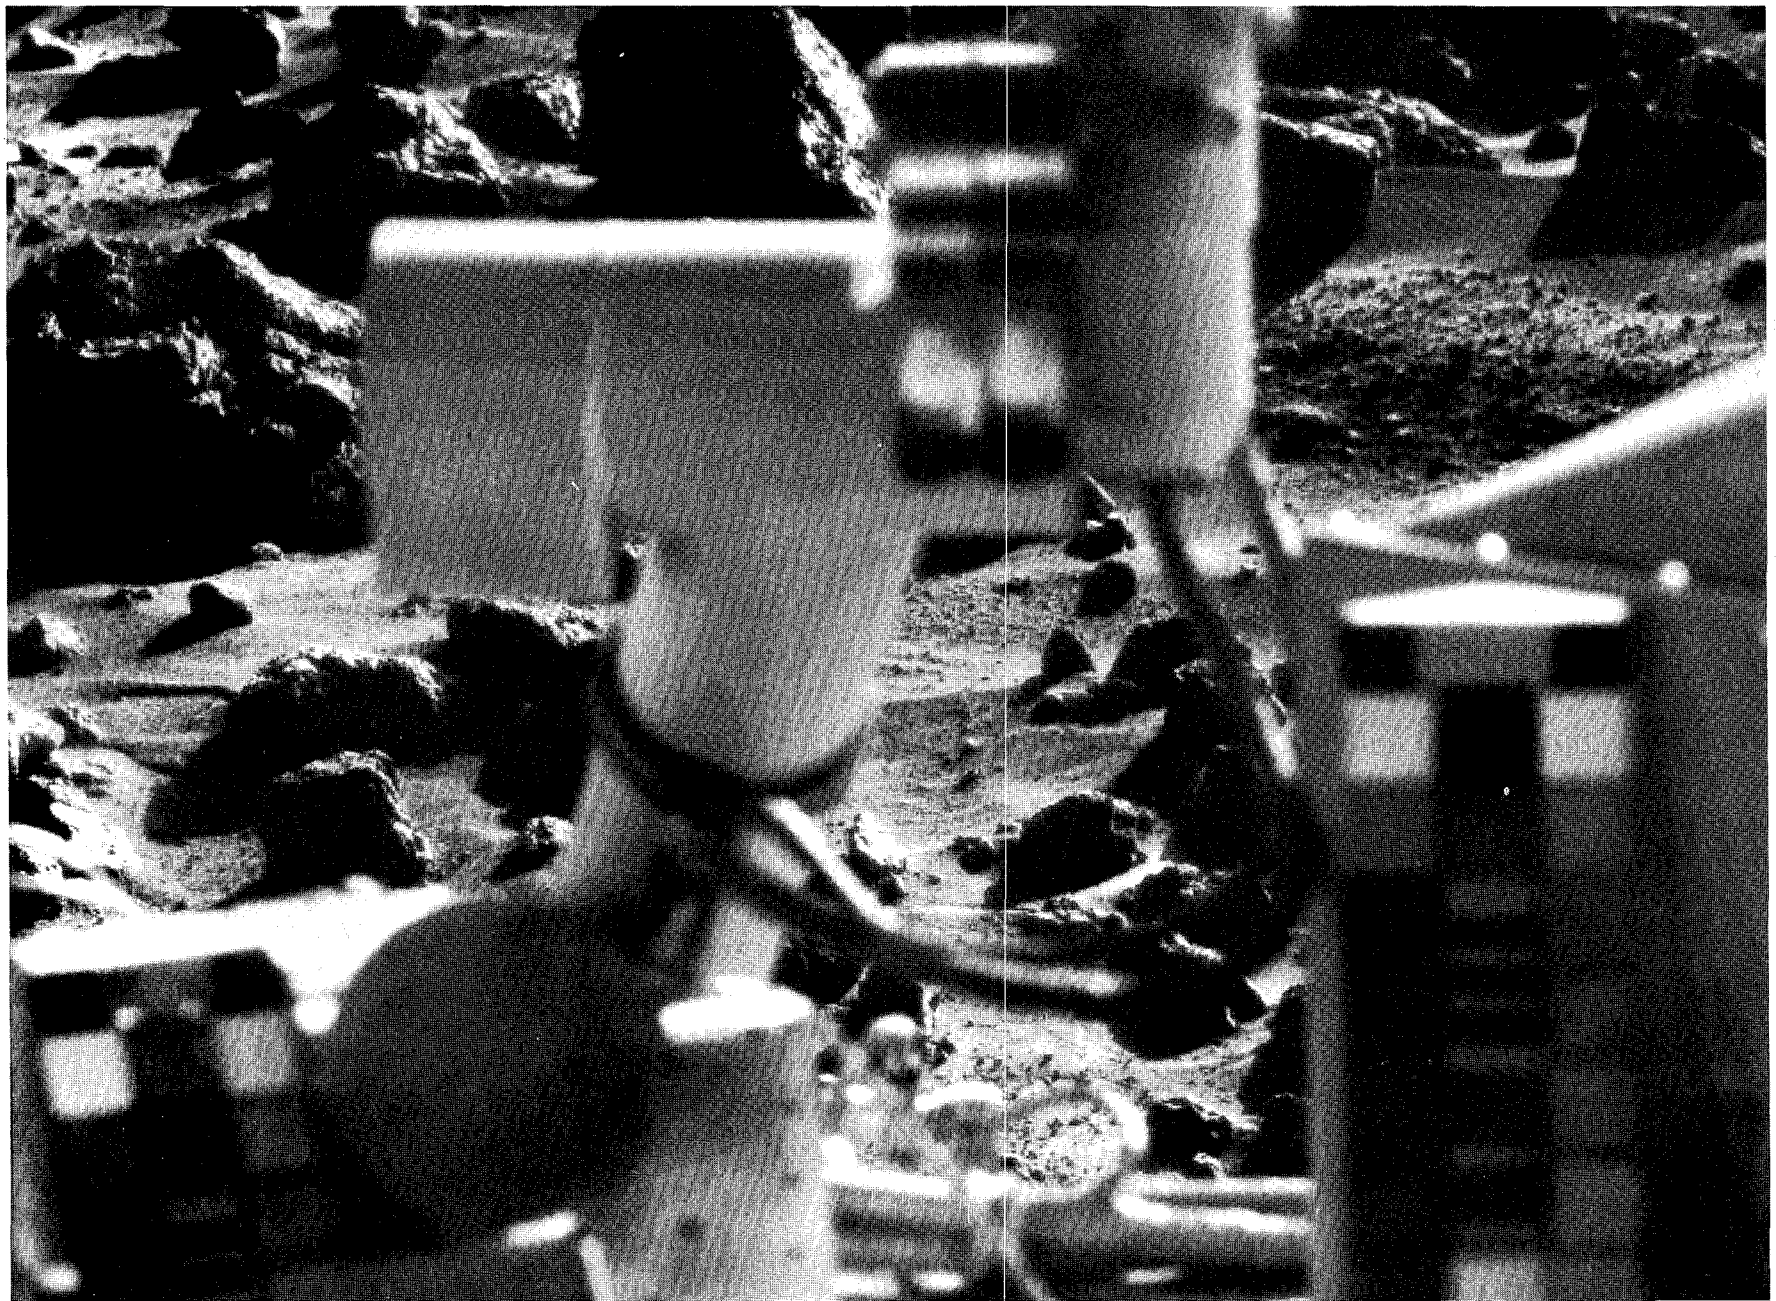
Figures 114 and 115 show a round 10 cm magnifying mirror in the foreground. During the mission, the sampler arm was positioned in front of this fixed mirror and the reflected image was photographed. In this way it was possible to get a 5X enlargement of magnetic soil particles adhering to the magnets on the sampler head. In the early morning view (fig. 114) an erosional collar of sediment is discernible around one of the blocks.
